Restoring severely discoloured anterior teeth using minimally invasive procedures

Author: Daniel Edelhoff and Oliver Brix

Daniel Edelhoff and **Oliver Brix** explain how they endodontically treated and restored severely discoloured upper central incisors

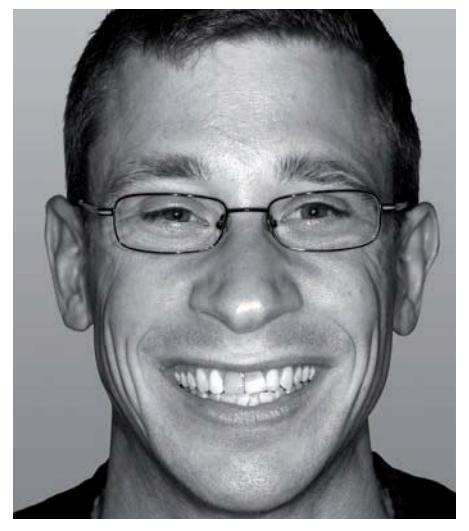
Figure 1: The pronounced discolouration and the inadequate tooth position of the upper central incisors impaired the aesthetic appearance

A 28-year-old male patient came to the practice and expressed the wish to have his endodontically treated and severely discoloured upper central incisors restored. He said that he had not experienced any problems since the resection of the root some years previously; however, he was dissatisfied with the impaired aesthetic appearance caused by the affected teeth (Figures 1 to 3).

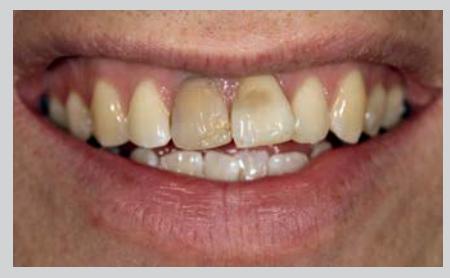
Figure 2: The severe discolouration of tooth UR1 also caused a discolouration of the marginal gingival area

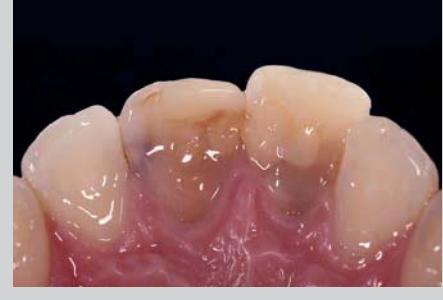
Figure 4 Leaking composite restorations and secondary caries in the endodontically treated teeth UR1 and UL1

root canal obturations in teeth UR1 and UL1. There were no signs indicating the presence of root canal posts, but the extensive composite restorations in both teeth were leaking and showed secondary caries (Figure 4). At the time of the clinical evaluation, the restorations were already five years old. The specific challenge facing the treatment team was the patient's wish to have the aesthetic appearance of his teeth restored in a timely fashion. The patient required that his natural tooth shade and position be restored and that the remaining tooth structure be stabilised as much as possible in the long term.

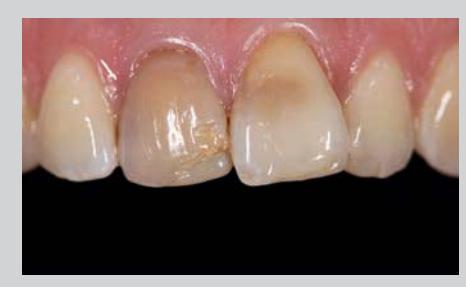
Figure 3: The asymmetrical tooth axes of the central incisors are clearly visible

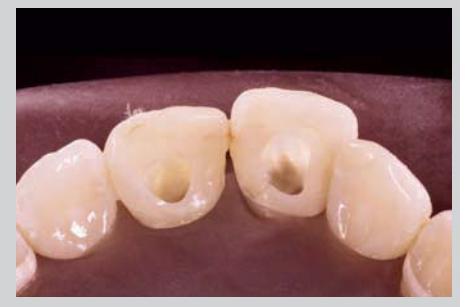
Figure 5: The root canal fillings were checked prior to the internal bleaching procedure, and the cementoenamel junction was sealed. The cavities were now ready for the application of the bleaching agent

After the coronal pulp chamber of the two incisors had been cleaned, an additional seal was placed at the cementoenamel junction using a small amount of phosphate cement. This measure ensured that the bleaching agent, which would be applied later, did not diffuse into these sensitive areas (Figure 5). For the internal bleaching, a mixture of sodium perborate powder and distilled water was applied using the walking bleach method. The palatal access to the coronal pulp chamber was sealed with cotton pellets soaked in bonding agent (Heliobond) and a lowviscosity composite (Tetric Evoflow). The next appointment was scheduled one week later. The desired tooth shade had not yet been achieved, and therefore fresh bleaching agent was applied. After another week with the bleaching agent in

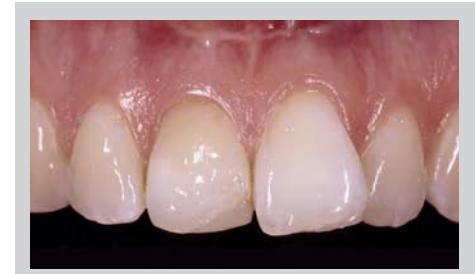
Figure 6: Two weeks later: The severe discolourations

place, a satisfactory brightness value was observed on both abutment teeth (Figure 6). A calcium hydroxide preparation (Calcipure) was inserted into the pulp chamber and left in place for a week in order to neutralise the bleaching agent.

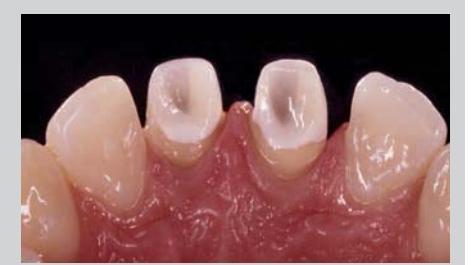
Figure 7: The built-up and prepared incisors. Given the severe degree of destruction, adhesively cemented fibre-reinforced composite posts combined with mouldable composite materials were used

was applied to create the direct buildup (Figure 7). A high-power curing light (Bluephase G2 with > 1,000 mW/cm2) was used for the final polymerisation of the cementation and buildup materials. A diagnostic pattern was employed for the minimally invasive preparation. This template was fabricated on the basis of the wax-up and contained all information relating to the correction of the tooth position and the outer contour of the final restoration.

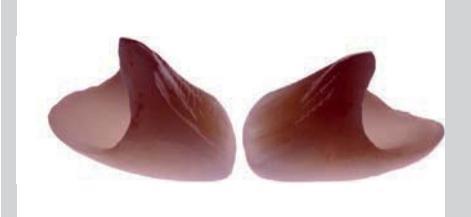
Figure 8: Lithium disilicate-based 360° veneers made of IPS E.max Press. In order to better mask the dental structure with a minimum layer thickness, an MO ingot was selected

The IPS Emax Press frameworks were veneered with the IPS Emax Ceram veneering ceramic in the shade A2 (Figure 8).

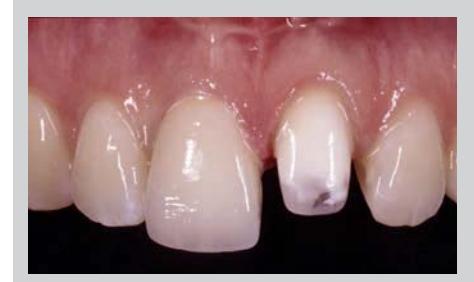
Figure 10: Frontal view of the veneers during try-in. The use of lithium disilicate as the basis of the restoration ensured a homogeneous appearance regardless of the substructure

A perfect masking of the abutment teeth was already achieved at this stage and the resulting situation showed a harmonious appearance regardless of the substructure (Figures 9 and 10).

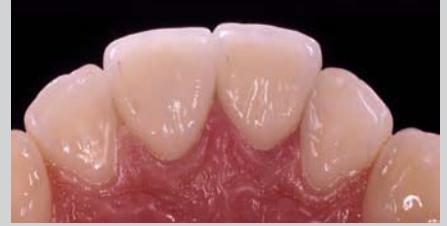
Figure 9: The optimum masking of the extensively built-up abutment teeth achieved by an MO ingot coping and a try-in paste in the shade whiteopaque became evident already during the try-in of the veneers

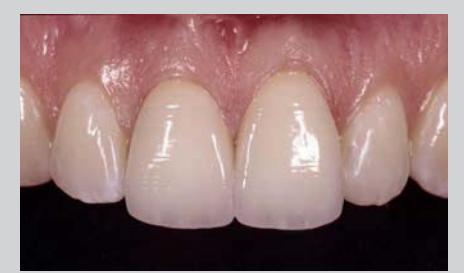
Figure 11: The 360° veneers were seated with the luting cement that corresponded to the try-in paste used; a multi-step dentine adhesive system was used. Thus, an excellent esthetic outcome could be achieved reliably and predictably.

The inner aspects of the glass-ceramic veneers were etched with a hydrofluoric acid gel (< 5% IPS ceramic etching gel) for 20 seconds. Subsequently, a bonding agent (Monobond Plus) was applied. Only the multistep dentine adhesive system Syntac was applied to the tooth. The restorations were luted into place with the Variolink II system (white-opaque) (Figure 11).

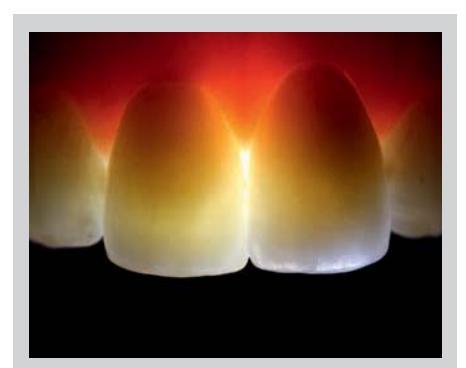
Figure 12: The restorations in transmitted light. By combining translucent build-up materials and glass-ceramic veneers, a light transmission that matches the properties of natural teeth was achieved

A light transmission that corresponds to that displayed by natural teeth was achieved by using translucent build-up materials in conjunction with glass-ceramic lithium disilicate veneers (Figure 12). The final outcome with regard to functional and aesthetic parameters was found to be very satisfactory at the final evaluation. The tooth shade was in perfect harmony with the surrounding dentition. In addition to removing the severe discolouration of the hard and soft tissues, we were able to correct the tooth position and adjust the tooth proportions (Figure 13). The patient was fully satisfied with the aesthetically pleasing outcome and did not experience any phonetic problems resulting from the correction of the tooth position (Figure 14). CPD

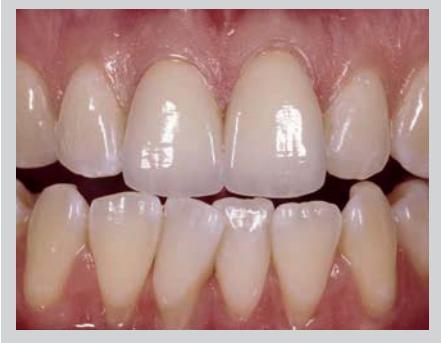
Figure 13: Postoperative view with mandible in protrusion. The final check of the functional and aesthetic parameters was satisfactory. The tooth shade excellently matched the adjacent teeth

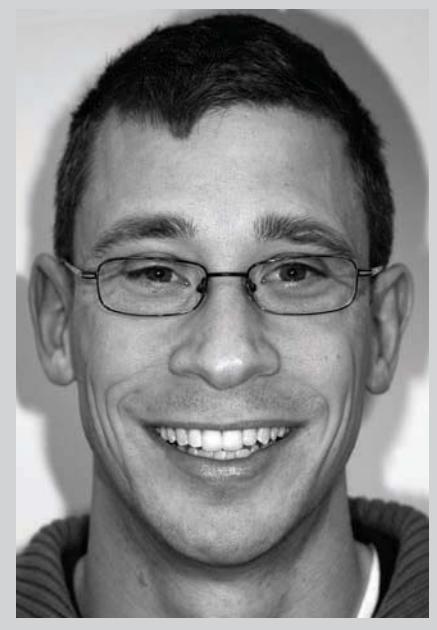
Figure 14: Portrait image of the final outcome: The discolourations were removed, the tooth position corrected and the tooth proportions adjusted (for comparison, see Figures 1 and 2)
